# **Best Value Case Study for Cold Storage Facility in Miami, Florida**

A cold storage facility had been reroofed in 2003 (investment of \$600,000) that required the removal of existing insulated roof and replaced with a 20 year modified bitumen roof. After six years, the facility posed a safety hazard due to the ice formations inside the cold storage facility. The source of the problem was not known. The traditional process of using a professional designer, a certified contractor, receiving a manufacturer's warranty, and having the roof inspected by the local government inspector could not assist the owner and the FM resolve the complex problem. The facility manager (FM) decided to utilize a non-traditional Best Value (BV) Performance Information Procurement System (PIPS) to identify and resolve the problem. The main difference of the system is that the best value vendor and not the owner determines the final scope. This paper documents the BV PIPS approach and the resulting performance. An inspection five years later verified the performance of the Best Value approach and showed the value of the installed sprayed polyurethane (SPF) roofing system.

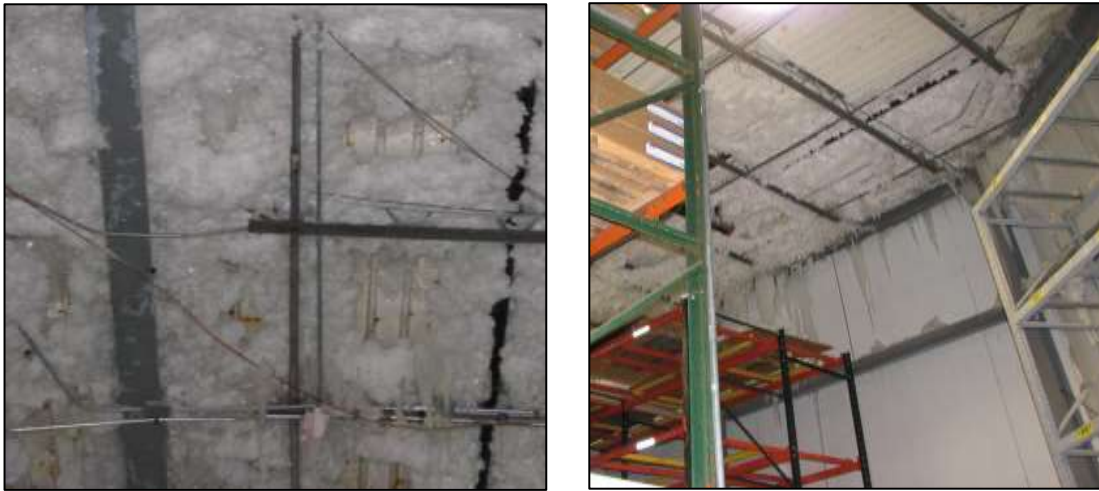
*Figure 1: Ice Formations*

The facility was reroofed in 2003 to eliminate problems with leaking and ice formation. The specifications were done by an engineering service representing the client. After six years [2009], ice continued to form in the cold storage facility as shown in Figure 1, and the facility management representative perceived that the problem had to be rectified even though it was a recently installed roofing system [six years previous].

After six years, without noticeable deterioration on the exterior roofing system, the cold storage facility was experiencing widespread and dangerous ice formations [as large as five feet in length]. The ice formations caused a safety hazard as well as a potential inefficient electrical usage. The cause of the problem was not immediately known, however, the facility manager representing the building owner along with the tenant proposed that a new roof may be required.

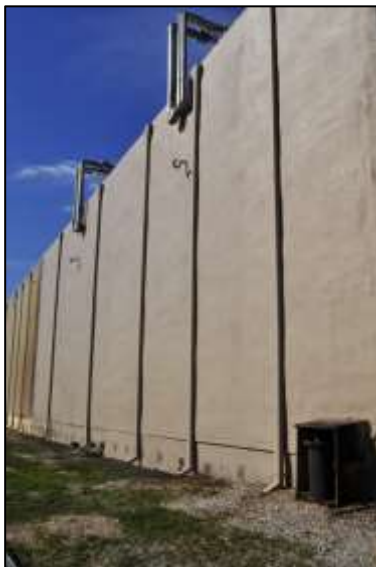
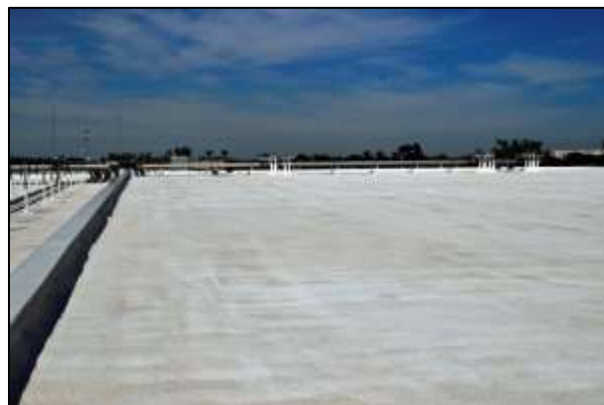
*Figure 3: Completed Project*

The BV test impressed the owner, the code compliance group, the facility manager and the tenant. The tenant management has been extremely pleased with the performance of the sprayed polyurethane and urethane waterproofing coatings on the wall and roofing system which has minimized the penetration of moisture and ice formation in a temperature differential of up to 130 degrees for over five years. Figure 3 shows the pictures of the wall insulation and the roof insulation after the project completion.
